# SIERRA 2.3 DOHC 8v HYBRID

## 2. Brief description of the 2.3 8v DOHC hybrid

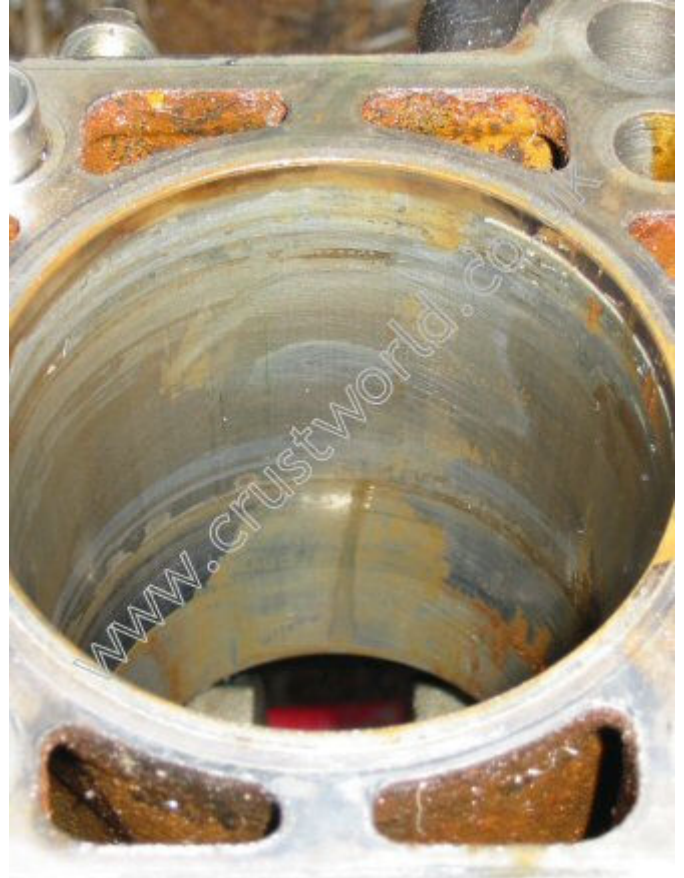
Here we see an example of one of the cylinder bores in the 2.3 block I obtained for my conversion. This engine had been standing in a scrapyards and then garage for nearly 2 years following a cylinder head gasket failure, and water had entered the bores leading to corrosion of the bores and piston rings.

All four bores were unworn but corroded and were salvaged using a couple of domestic nylon pan scourers to remove the light surface corrosion and then a glaze-breaking tool mounted in an electric hand drill to dress (or “hone”) the surface – roughening it sufficiently to help replacement piston rings bed in, and remove any final stubborn corrosion left behind by the nylon scouring pads.

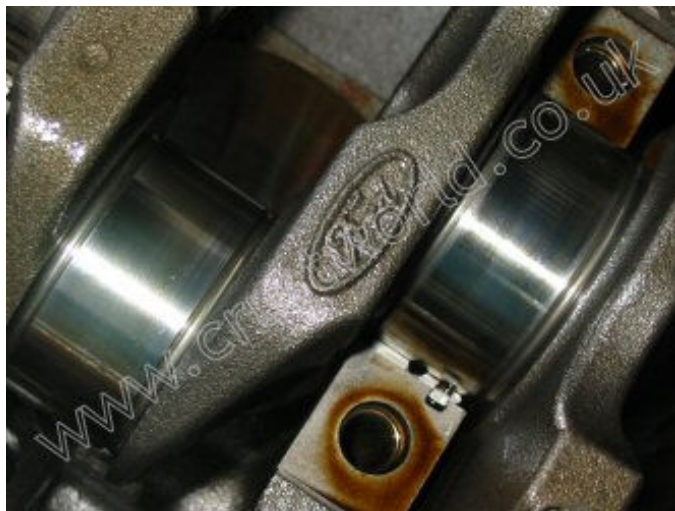
Having checked, cleaned and dressed the cylinder bores, attention then turned to the crankshaft and the bearing journals. As can be seen from the image below, the journals were in pretty good shape – no visible scoring, cracking or other indication of wear – and it was decided that the crank could be re-used “as is” with just new main and big-end bearing shells fitted.

As the old bearings showed no major or concerning signs of wear, it was decided to replace them with identically-sized shells, and check the running clearances with “Plastigauge”.

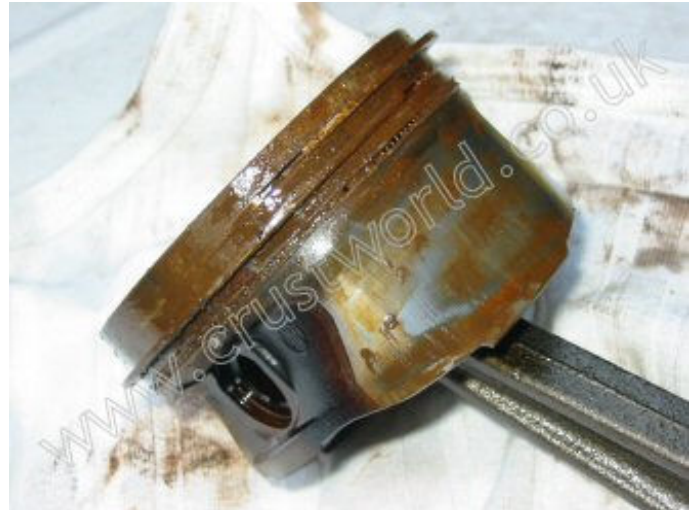
However, given the state of the cylinder bores, the pistons weren't in quite as good condition as the crank as the following photograph shows.

Moisture had caused corrosion in the piston rings, which had combined with oil present and more moisture to create a rusty “gunge” that glued the piston rings together and effectively stuck them in the grooves.

The damage was not as severe as it looked. Having removed the rings, gentle use of the nylon pan scouring pads and a suitable degreasing agent brought the pistons to an almost “good as new” condition.

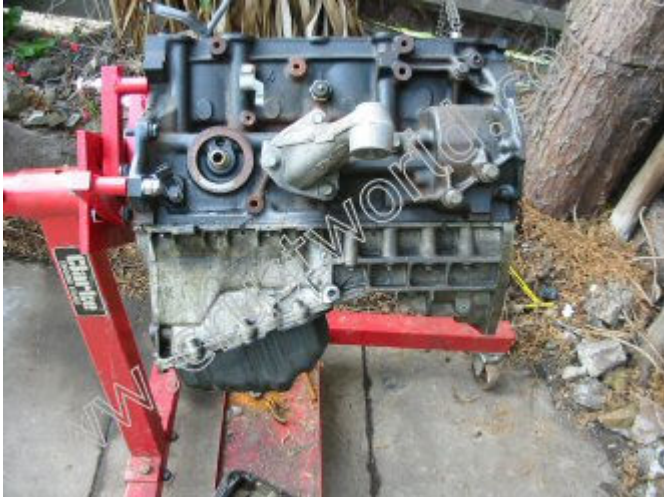
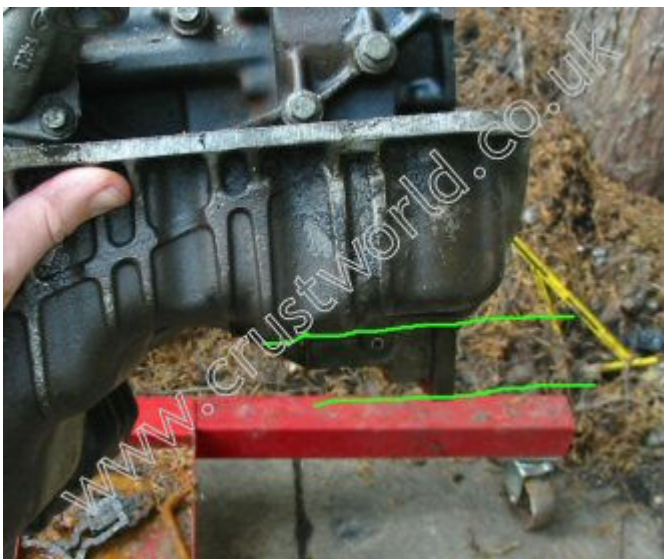
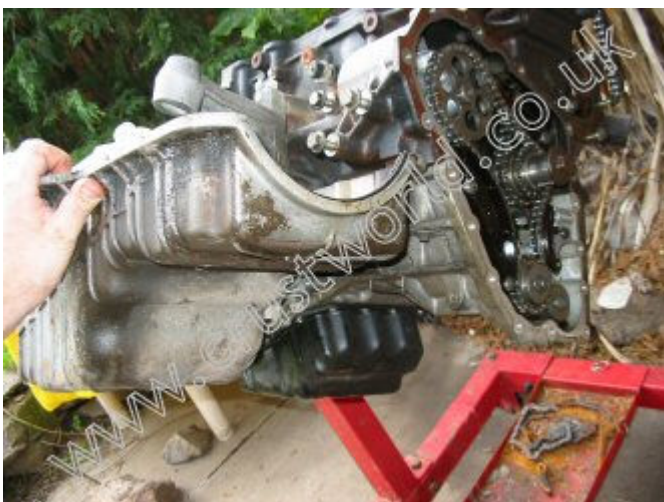
As can be seen from the three photographs below, while the majority of the standard 2.3 sump is the same size as the 8v 2.0 sump held against it for comparison purposes, the front section is vastly different and will foul the Sierra steering rack and cross member.

However, it is not quite as simple as just changing the sumps – it is necessary to firstly block up the oil feed to the balancer shafts in the block (*to not do so will result in a massive loss of oil pressure*), install a “fillet” piece to make good a section of the block machined away at the factory to provide access for the balancer shaft drive chain, and fit the 8v oil pickup tube, oil splash shield and front sump mounting plate.

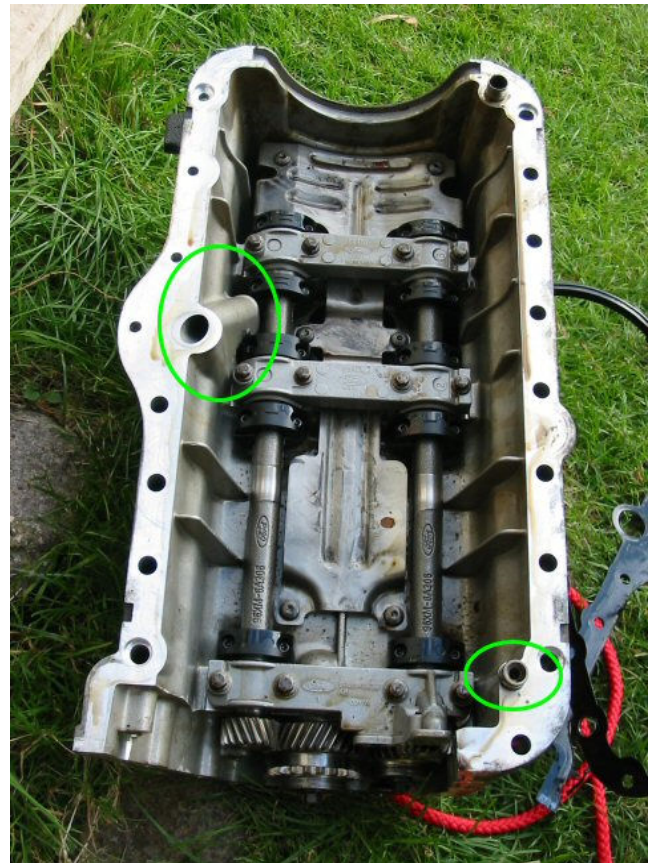
Note the integral oil-pickup pipe (circled, left) and the oil feed for the balancer shafts contained in the locating dowel (circled, lower right)

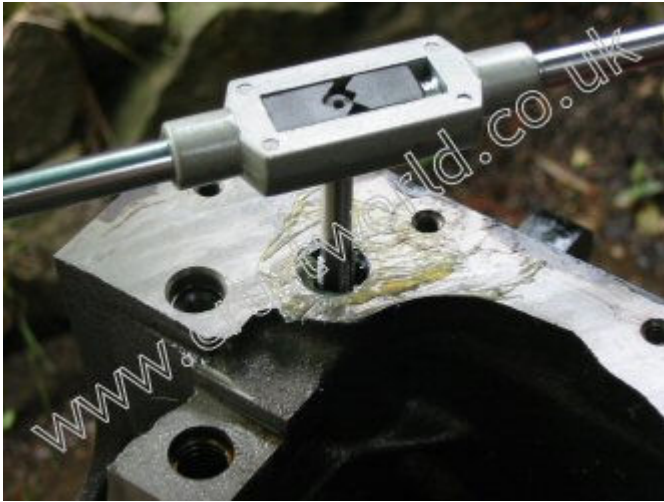
The first job after stripping down and cleaning the engine components is to seal the oil feed to the balancer shafts. This is located in the hole for the front sump locating dowel.

Using grease packed in the feed hole to catch swarf, a thread is cut using an M8 x 1.25 tap.

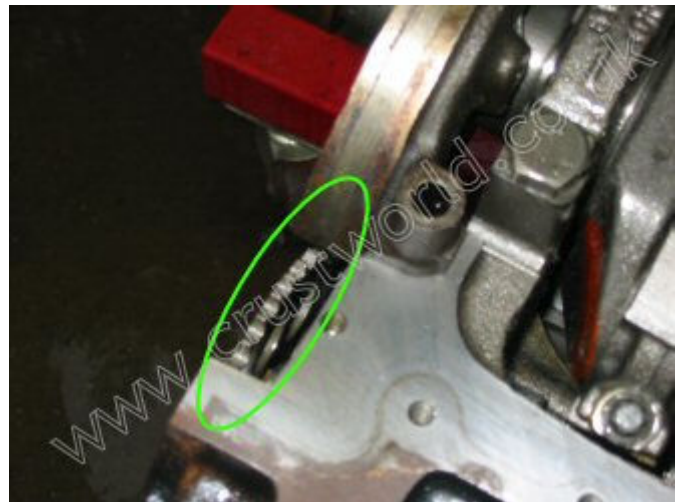
The photograph opposite shows the gap (circled) that the fillet piece needs to fill once the front sump mounting plate is installed.

The recommended course of action with relation to the fillet piece is to make a pattern – possibly from wood, or even plastiscene – and get an engineering company to machine up an aluminium or steel equivalent that will fit the gap perfectly.

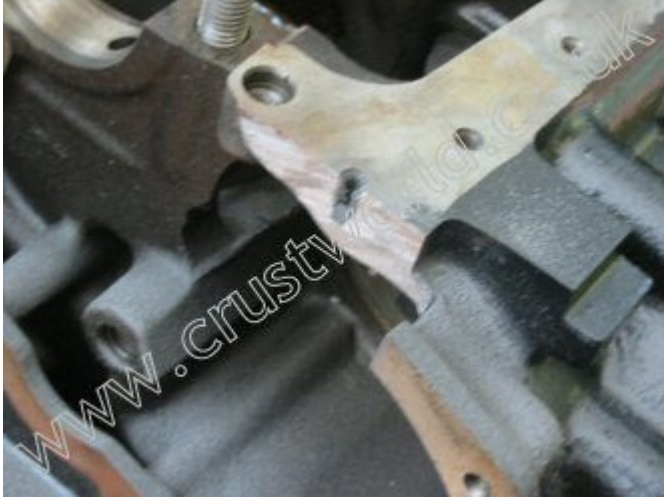
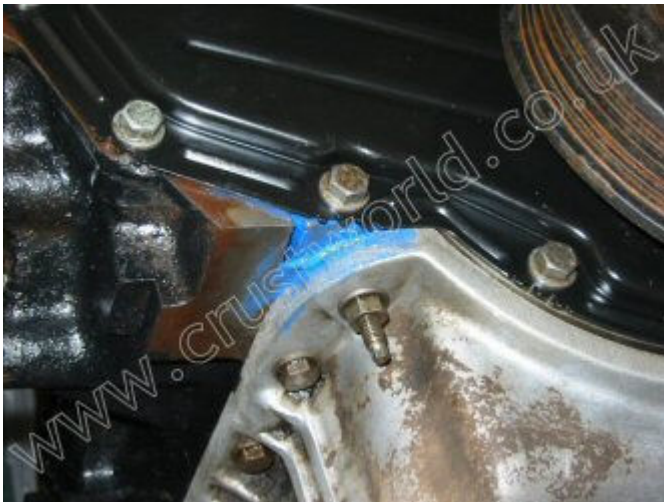
While this is not the preferred method of creating a fillet to replace the machined-out section of the 2.3 block, it has been surprisingly acceptable so far with no leaks. It is held firmly in position by one of the front lower timing cover bolts, and the adhesive action of the flange sealer.

By taking a hacksaw to the 2.0 block and grinding the resultant off-cut carefully with a bench grinder, a filler

piece was created that fitted better than expected – the gaps surrounding it being taken up with 'Loctite' silicon-based flange sealant.

Above, the section removed from the 2.0 block and below, sealed into position on the completed engine.

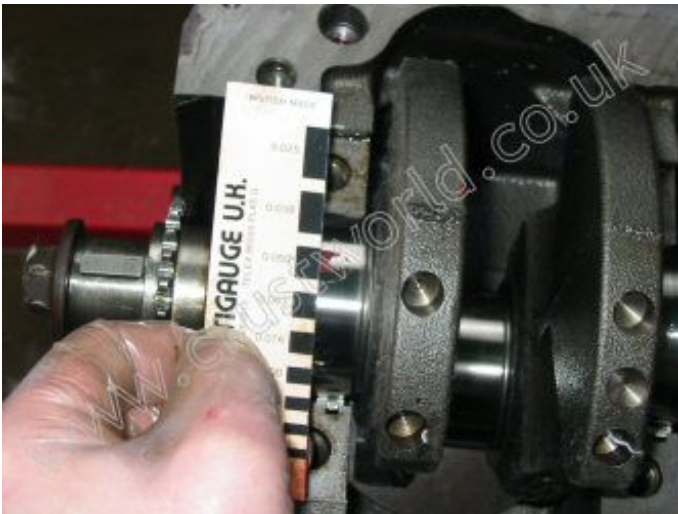
*The running clearance of number 1 main bearing is checked using "plastigauge". The width of the compressed element is compared against the card scale, showing the bearing is "in tolerance"*

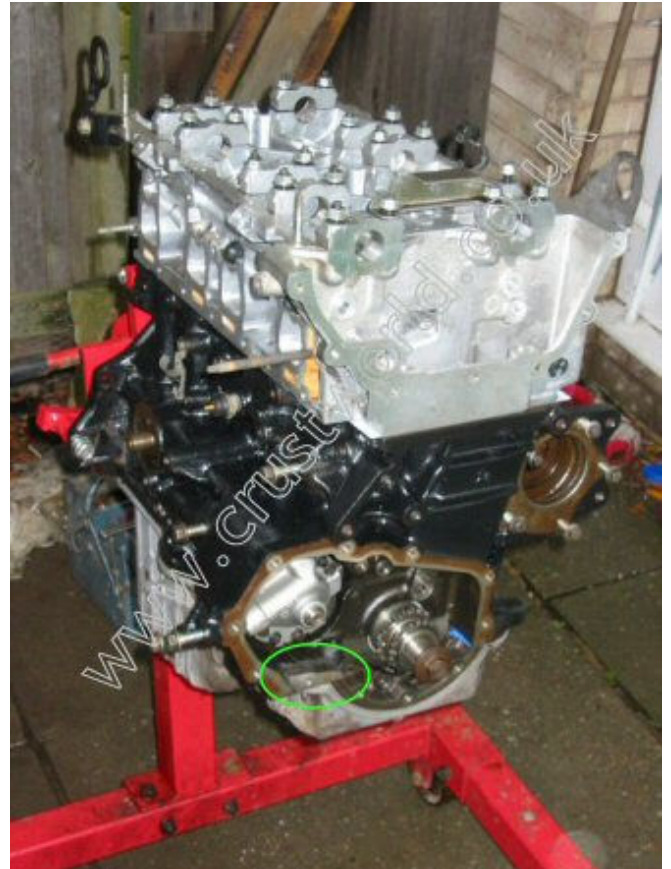
*The 8-valve cylinder head in place on the 2.3 short block. Note the fillet piece to block the hole left in the block by the drive chain for the balancer shafts (circled)*
