# SIERRA 2.3 DOHC 8v HYBRID

## 2. Brief description of the 2.3 8v DOHC hybrid

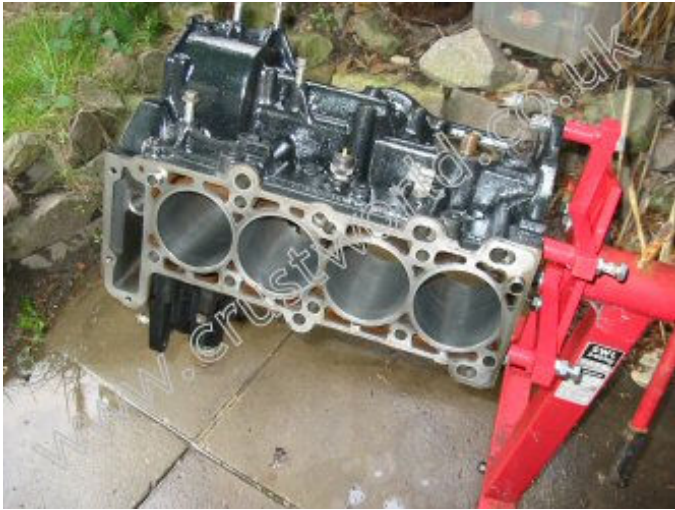
Here we see an example of one of the cylinder bores in the 2.3 block I obtained for my conversion. This engine had been standing in a scrapyards and then garage for nearly 2 years following a cylinder head gasket failure, and water had entered the bores leading to corrosion of the bores and piston rings.

All four bores were unworn but corroded and were salvaged using a couple of domestic nylon pan scourers to remove the light surface corrosion and then a glaze-breaking tool mounted in an electric hand drill to dress (or “hone”) the surface – roughening it sufficiently to help replacement piston rings bed in, and remove any final stubborn corrosion left behind by the nylon scouring pads.

The photograph overleaf shows the block after it had been stripped, cleaned and degreased, painted with black engine lacquer and the bores had been honed.

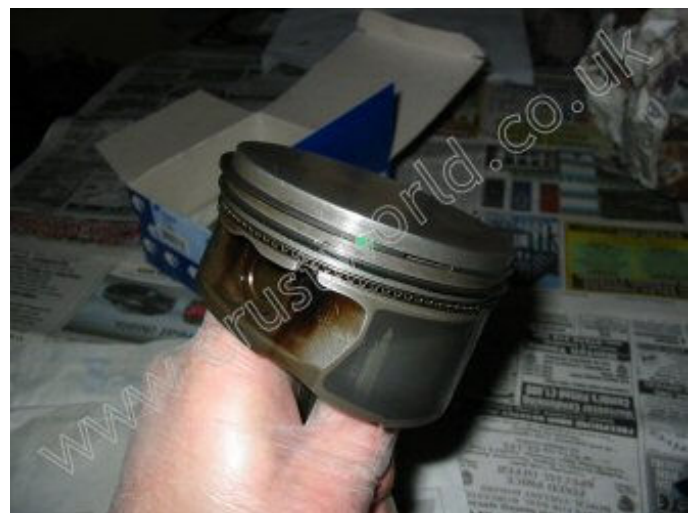
However, given the state of the cylinder bores, the pistons weren't in quite as good condition as the crank as the following photograph shows.

Moisture had caused corrosion in the piston rings, which had combined with oil present and more moisture to create a rusty “gunge” that glued the piston rings together and effectively stuck them in the grooves.

The damage was not as severe as it looked. Having removed the rings, gentle use of the nylon pan scouring pads and a suitable degreasing agent brought the pistons to an almost “good as new” condition.

Cleaned, the pistons were fitted with new piston rings at a cost of £120 for the engine set before being refitted into the engine block.

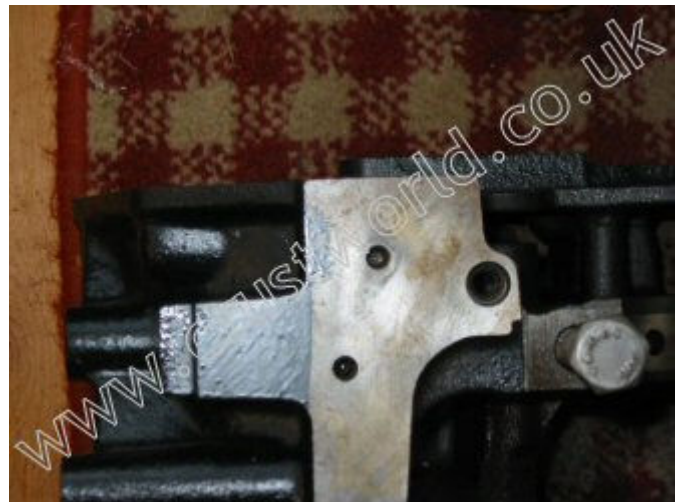
Comparing the same section of the 2.0 (top) and the 2.3 blocks (bottom) reveals an interesting similarity.

It seems that the bulk of the fillet could be cut from the 2.0 block and transferred across – though an alternative solution would have to be found for filling the gap to the left of the green line highlighted on the 2.3 block, below.

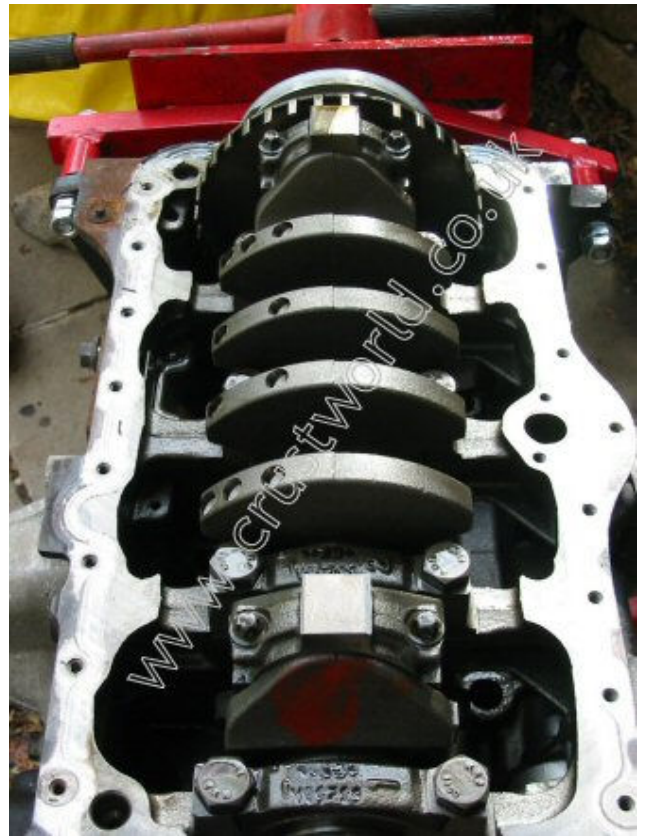
The oil splash shield is a shaped metal plate that bolts onto studs integral with the securing bolts on main bearing caps number 3 and 5. As the 2.3 has no need for a separate splash shield, the main bearing cap bolts do not feature the integral studs for mounting the 8v item

against, as can be seen from the following picture showing the 2.3 crank assembly (*taken before stripping*).

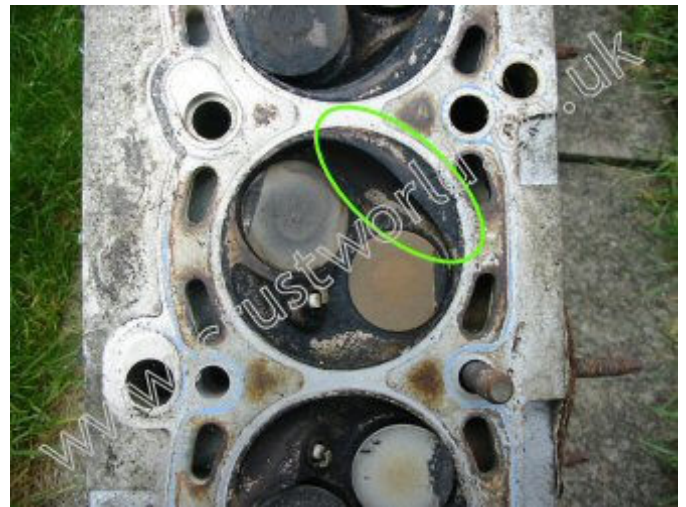
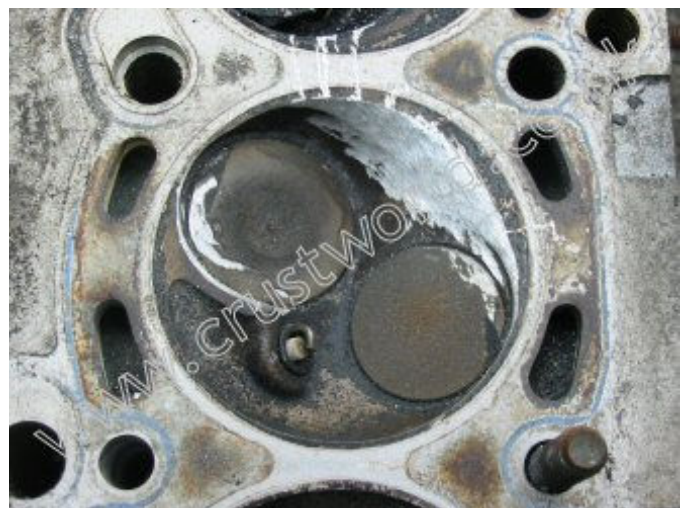
My main area of interest was in the shaping of the combustion chamber itself:

By machining away the material opposite the spark plug, I discovered I could safely remove the required 2cm<sup>3</sup> of material to bring the compression ratio down to 10.5 : 1 without affecting the strength of the casting – test holes drilled subsequently revealed the aluminium alloy is surprisingly thick at this point.

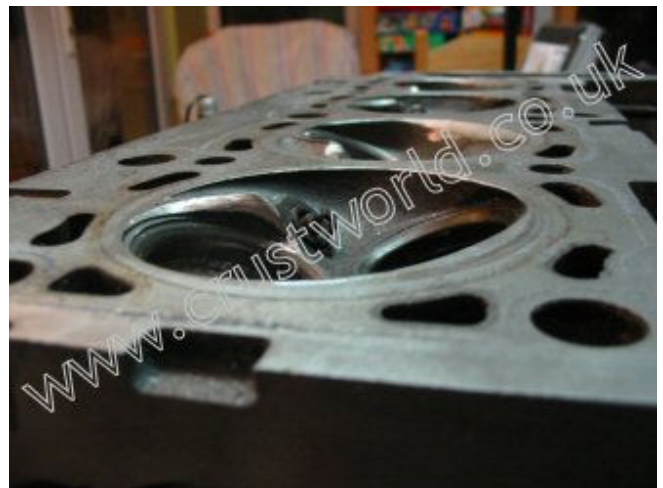
*Combustion chambers completed – note the chamfer around the edge of the combustion chamber to give a better "squish band" and prevent the production of hotspots around the edge of the head, and the modified swirl wall next to the inlet valve and spark plug.*

...and based on the experiments with the scrap cylinder head, the combustion chambers were ground out and sized as evenly and closely to 50cm<sup>3</sup> as possible.
